FIELD OVERSIGHT SUMMARY REPORT
ACS NPL SITE
GRIFFITH, INDIANA
February 6, 1997 - March 28, 1997

**USEPA/ARCS V
BVSPC Field Oversight Summary**

Reporting Period: February 6, 1997 - March 28, 1997

Site Name/Location: ACS, Griffith, IN

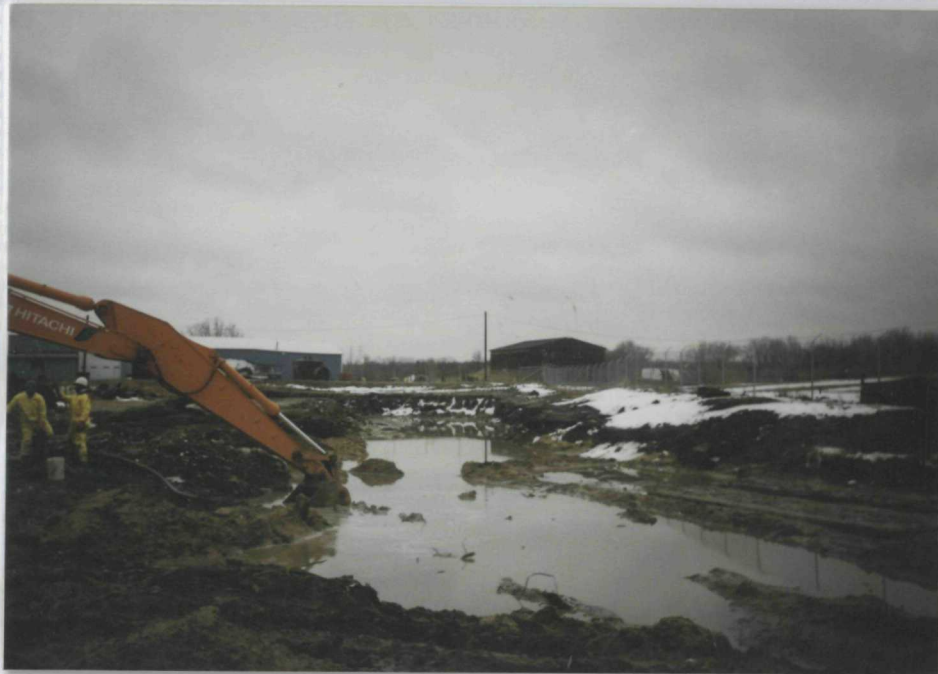
Description: Facing south-west. A typical barrier wall joint. Variation in upper clay layer elevations along the barrier wall alignment is reflected in the difference in height of the two wall panels.

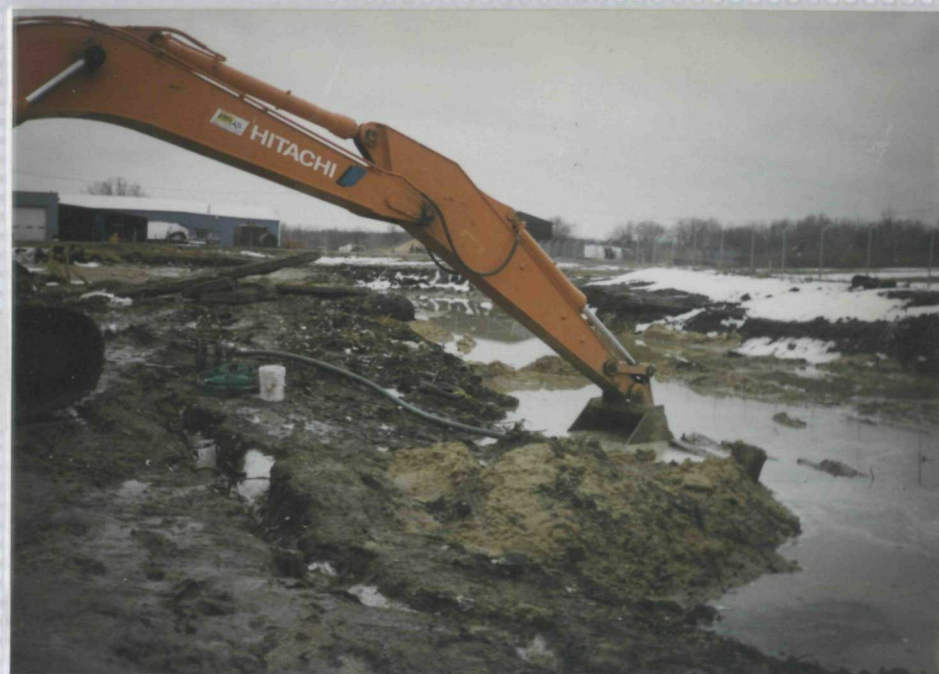
Site: American Chemical Services, Inc. RD/ERA
 Proj. #: 71670.600
 Roll: 3 Photo #: 45
 Date: 02-27-97 Time: 0955
 Photographer: Ashok Rupani
 Description: Facing south. Stormwater collected in the pre-excavated/benched areas of barrier wall alignment in the OFCA.

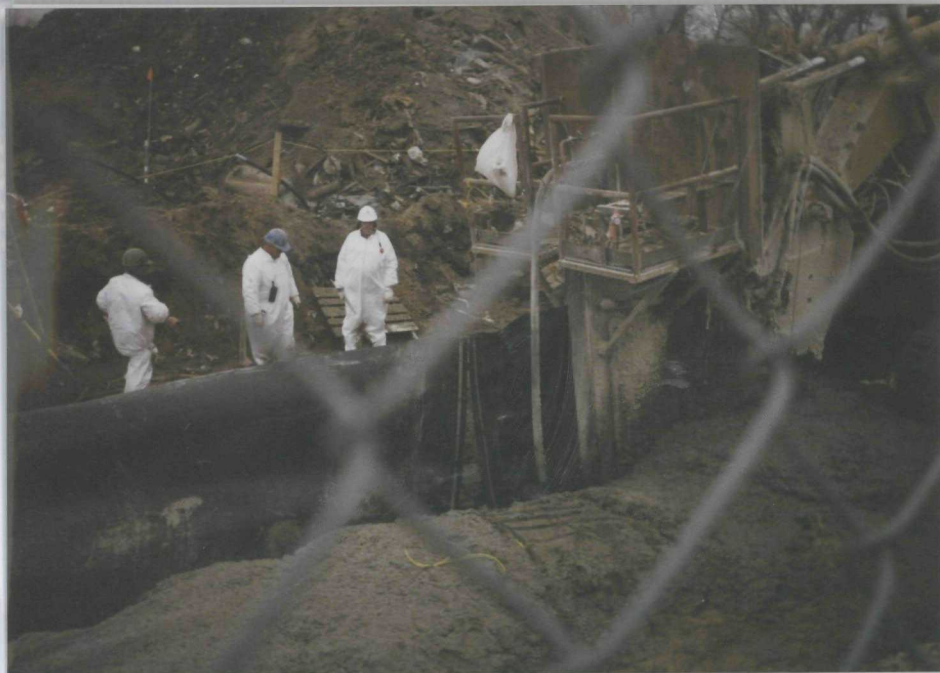
Description: Facing north-east. HTI making a joint during barrier wall installation along the southern leg of the alignment.

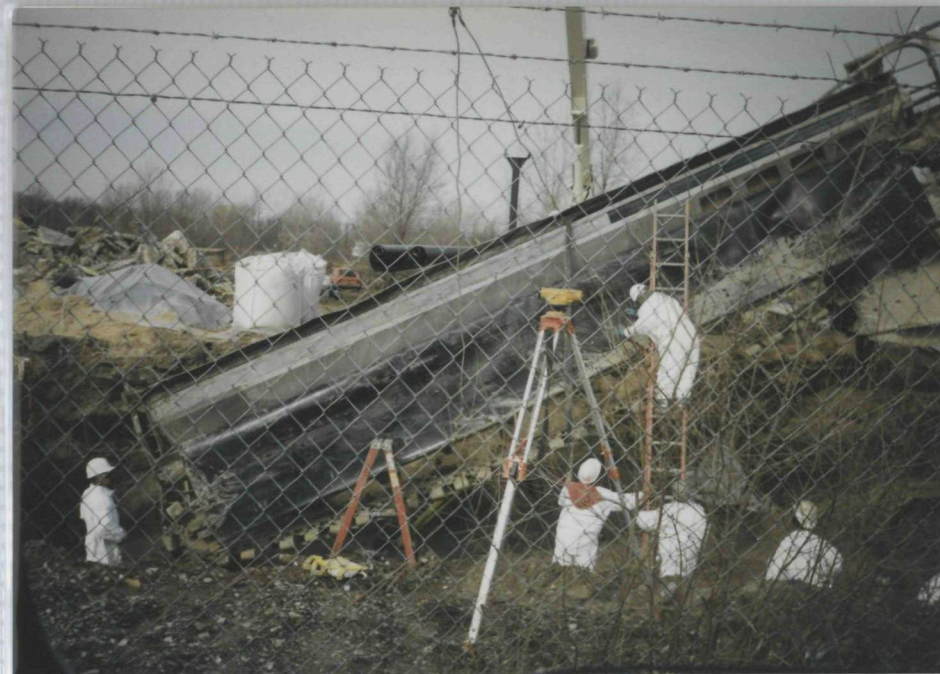
Site: American Chemical Services, Inc. RD/ERA
 Proj. #: 71670.600
 Roll: 3 Photo #: 50
 Date: 03-04-97 Time: 1330
 Photographer: Ashok Rupani
 Description: Facing north. HTI repairing the installation boot of the trenching machine after a joint pulled apart during installation along the southern leg of the alignment.

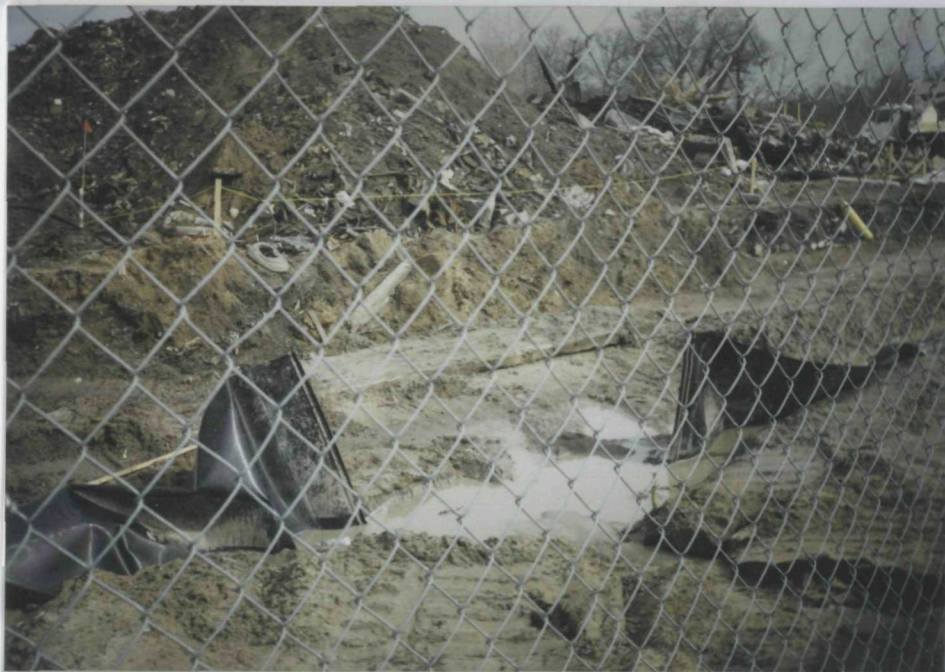
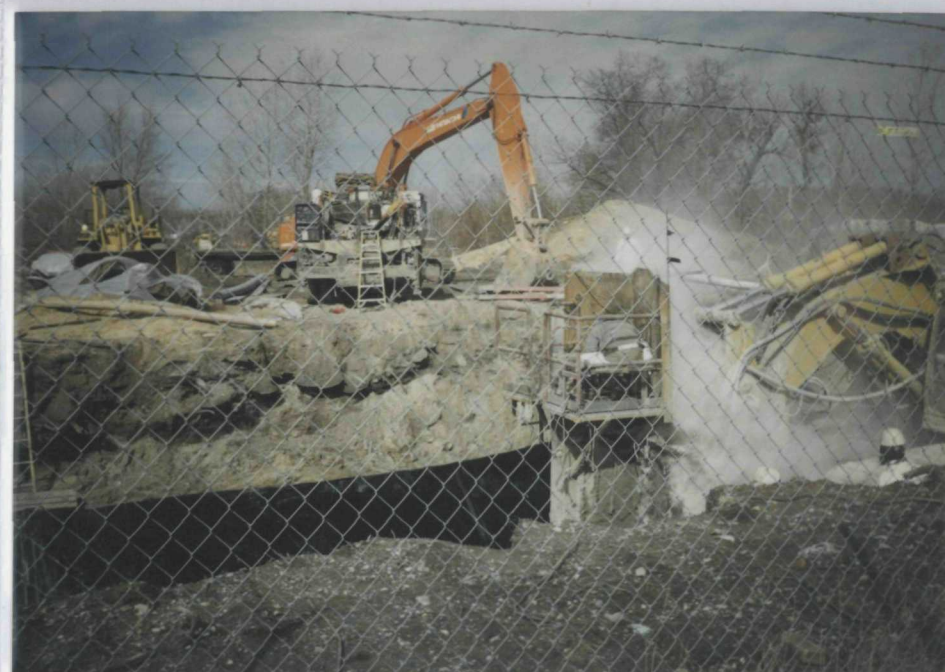
Description: Facing north-east. HTI installing barrier wall along the southern leg of the alignment.

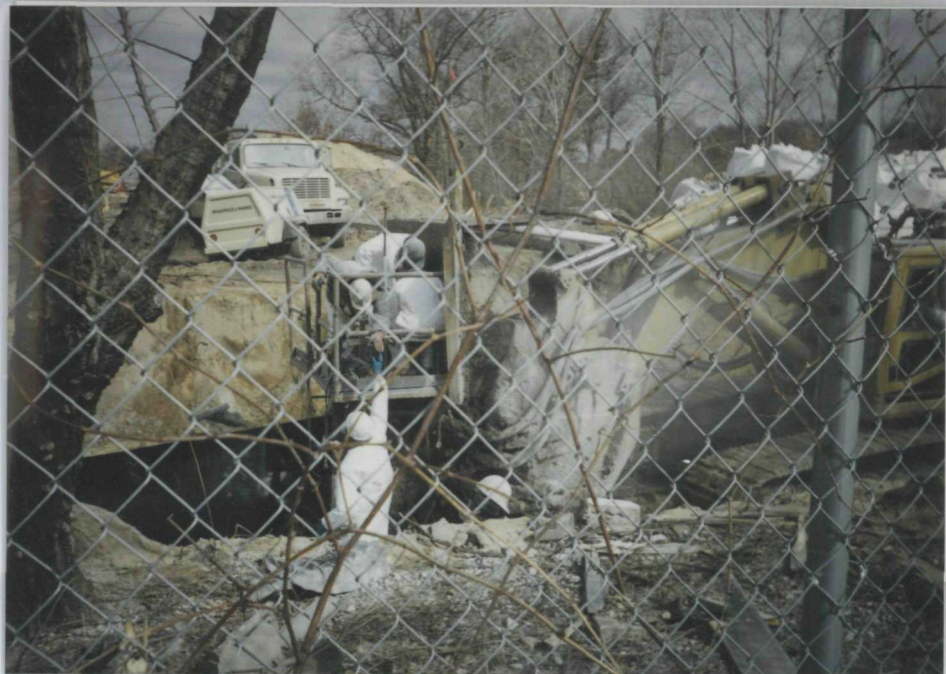
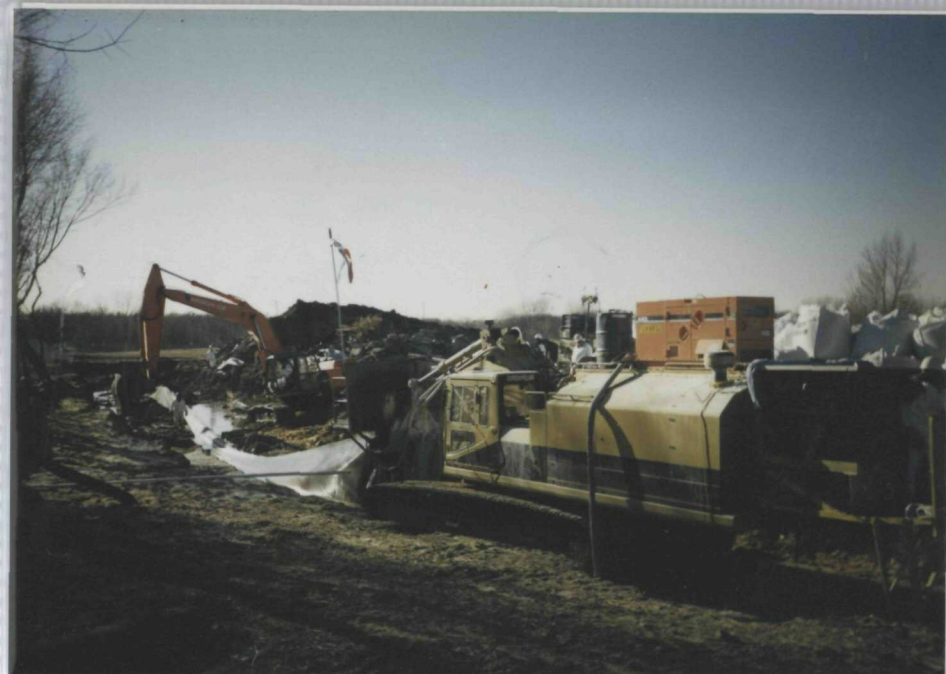
Description: Facing west. HTI installing barrier wall near the south-east corner of the OFCA.

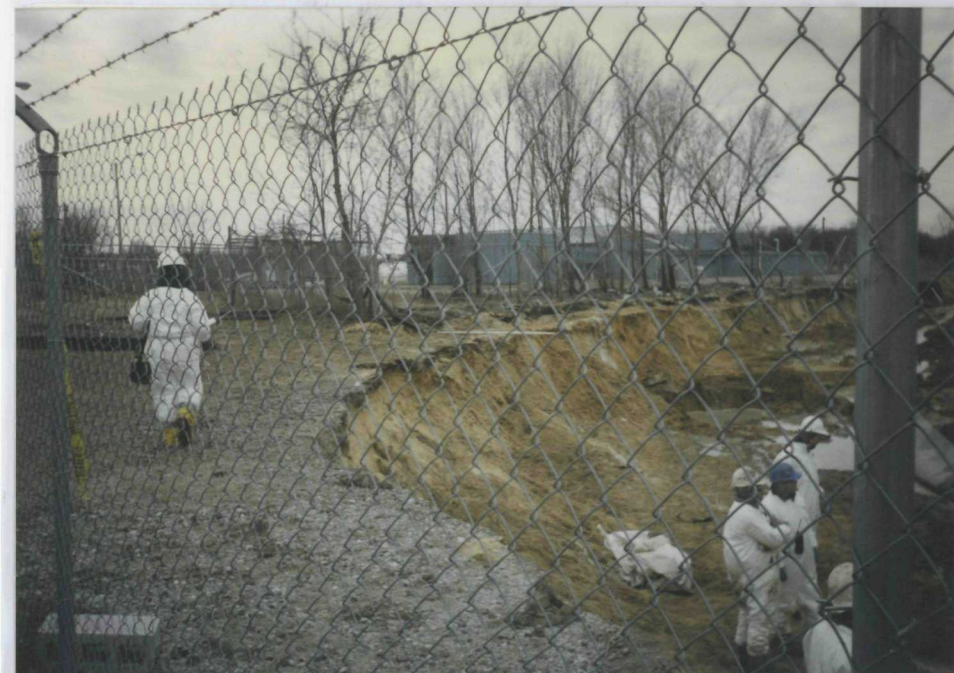
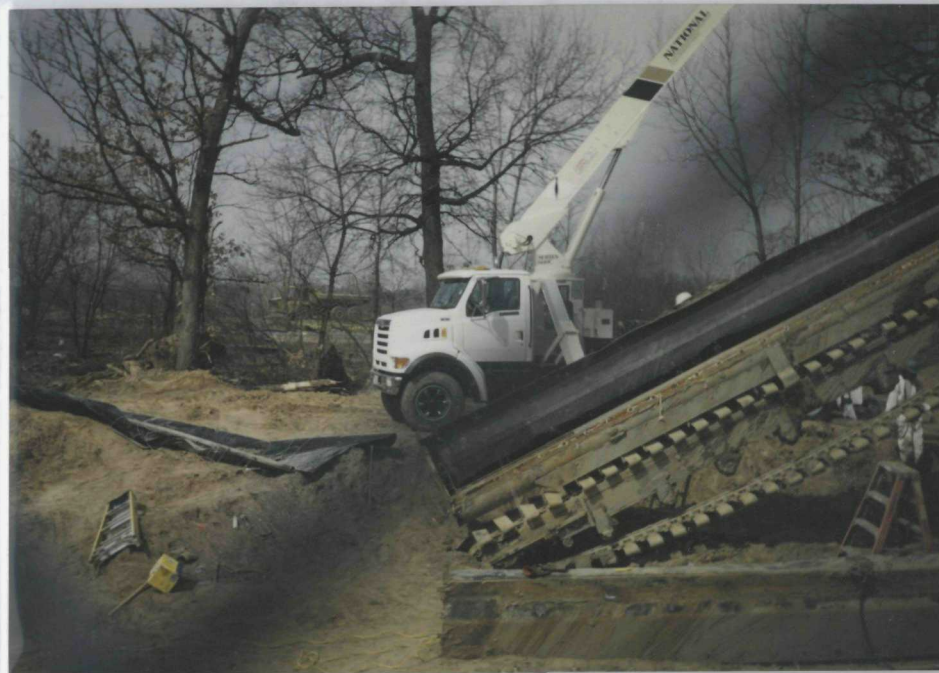
Site: American Chemical Services, Inc. RD/ERA
 Proj. #: 71670.600
 Roll: 3 Photo #: 55
 Date: 03-12-97 Time: 1120
 Photographer: Ashok Rupani
 Description: Facing south-west. Montgomery-Watson personnel conducting perimeter air monitoring during barrier wall installation activities near the south-east corner of the OFCA.

Site: American Chemical Services, Inc. RD/ERA
 Proj. #: 71670.600
 Roll: 4 Photo #: 56
 Date: 03-21-97 Time: 1130
 Photographer: Ashok Rupani
 Description: Facing west. HTI repairing the installation boot and cutting chain of the trenching machine after cobbles and boulders, encountered during barrier wall installation near the south-east corner of the OFCA, damaged the installation boot and the cutting chain of the machine.

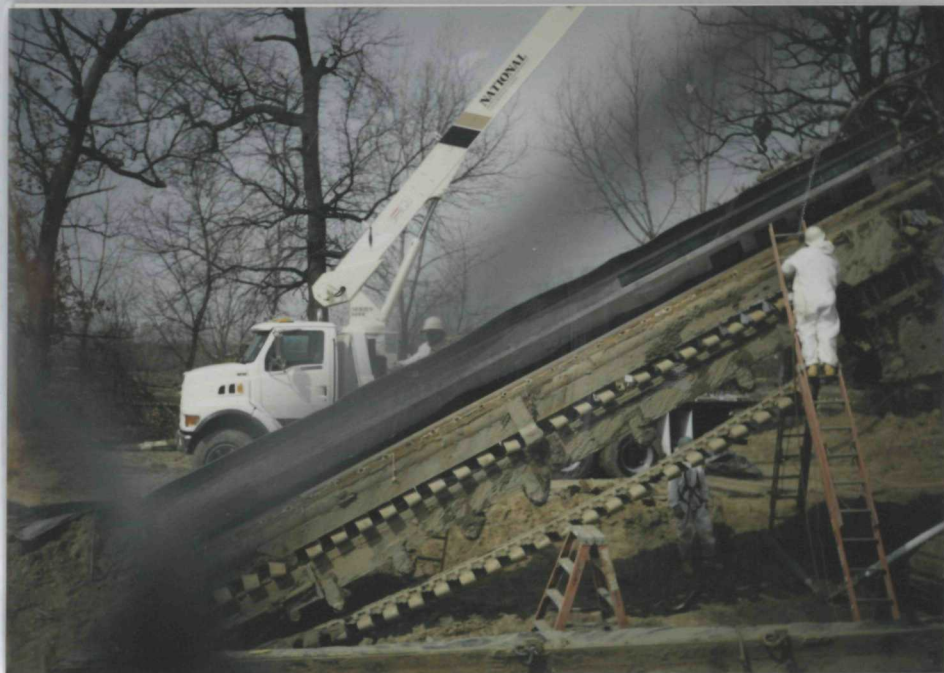
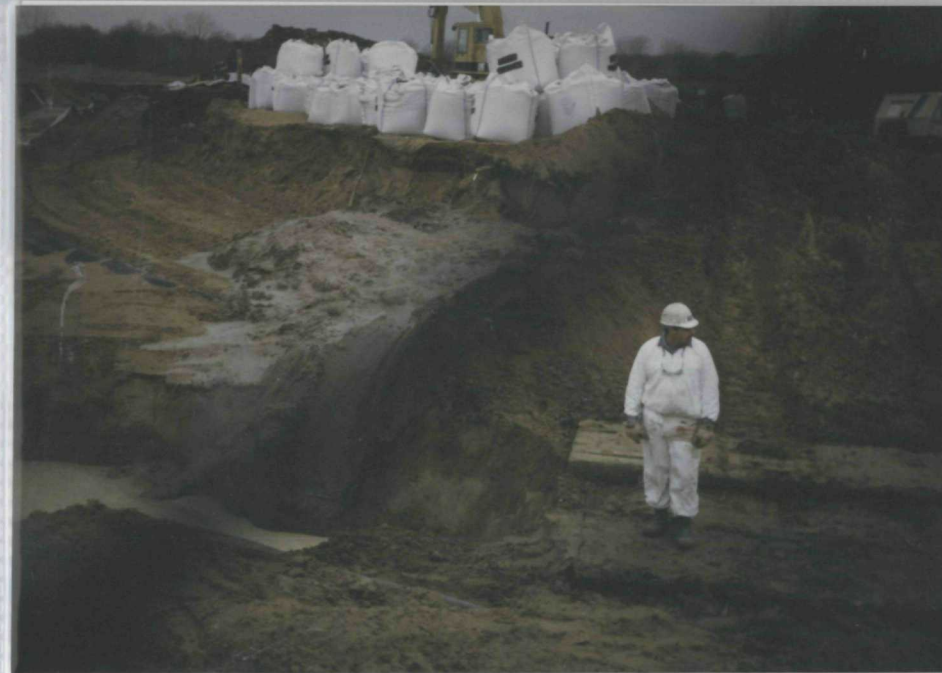
Description: Facing west. HTI repairing the installation boot and cutting chain of the trenching machine after cobbles and boulders, encountered during barrier wall installation near the south-east corner of the OFCA, damaged the installation boot and the cutting chain of the machine.

Description: Facing west. After repairing the installation boot and the cutting chain of the trenching machine, HTI resumes barrier wall installation near the south-east corner of the OFCA.

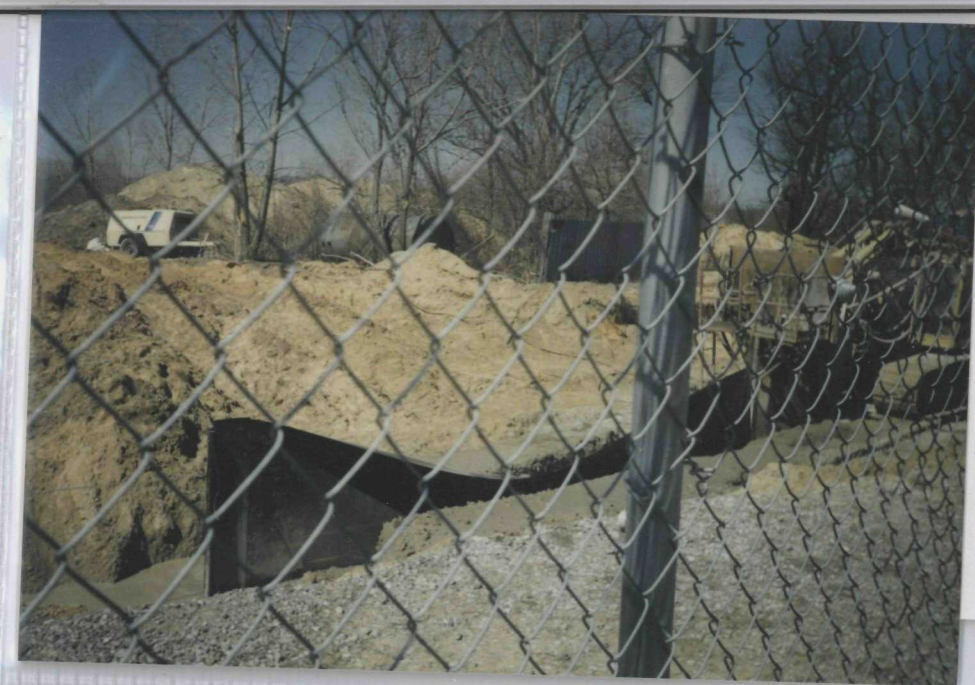
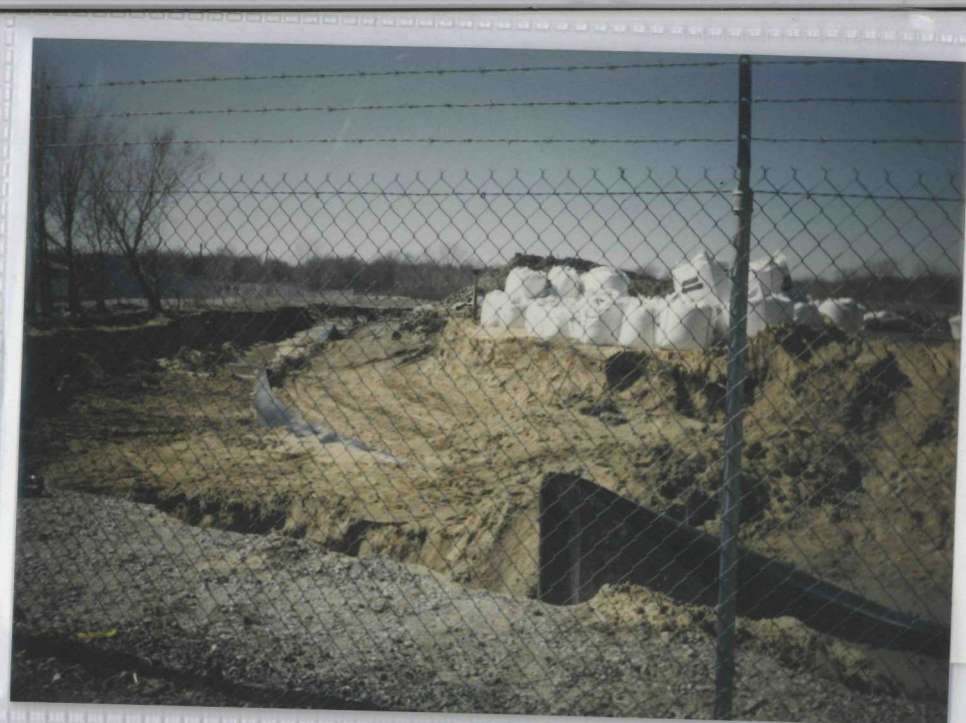
Description: Facing west. HTI resumes barrier wall installation near the south-east corner of the OFCA with a new panel beginning at a location few feet north of the last panel.

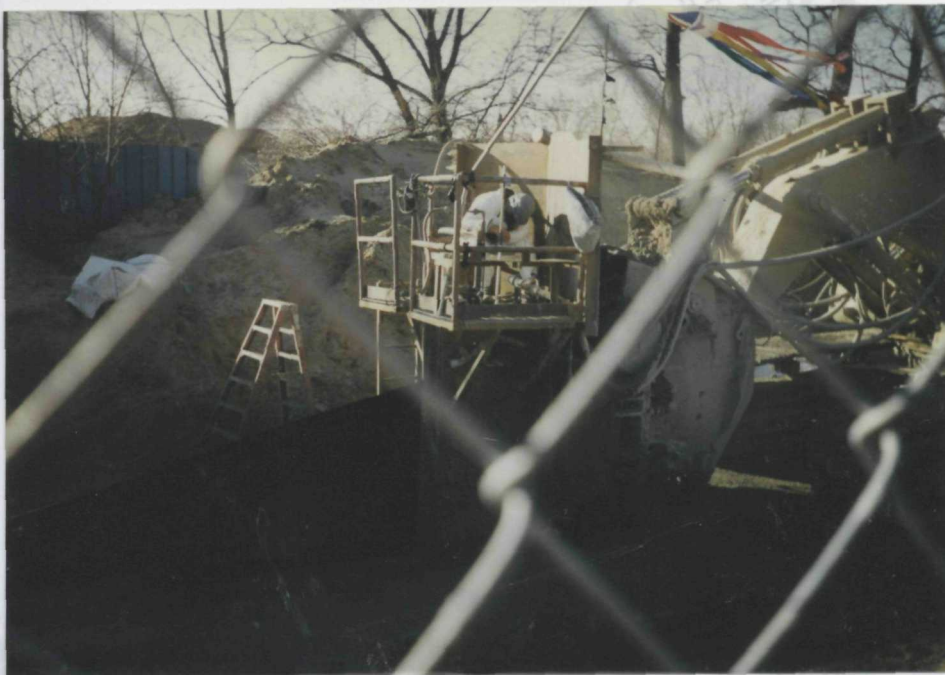
Description: Facing north-west. HTI installing barrier wall along the eastern leg of the alignment.

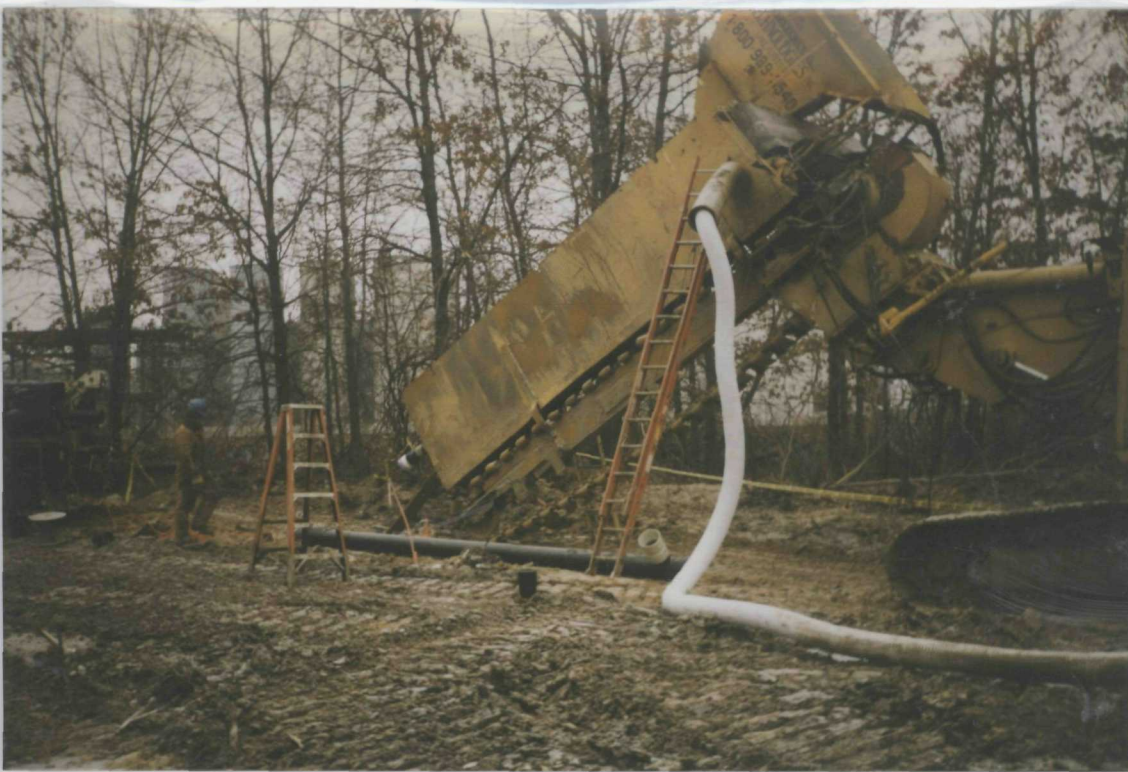
Description: Facing north-east. HTI setting up to install extraction trench #11.

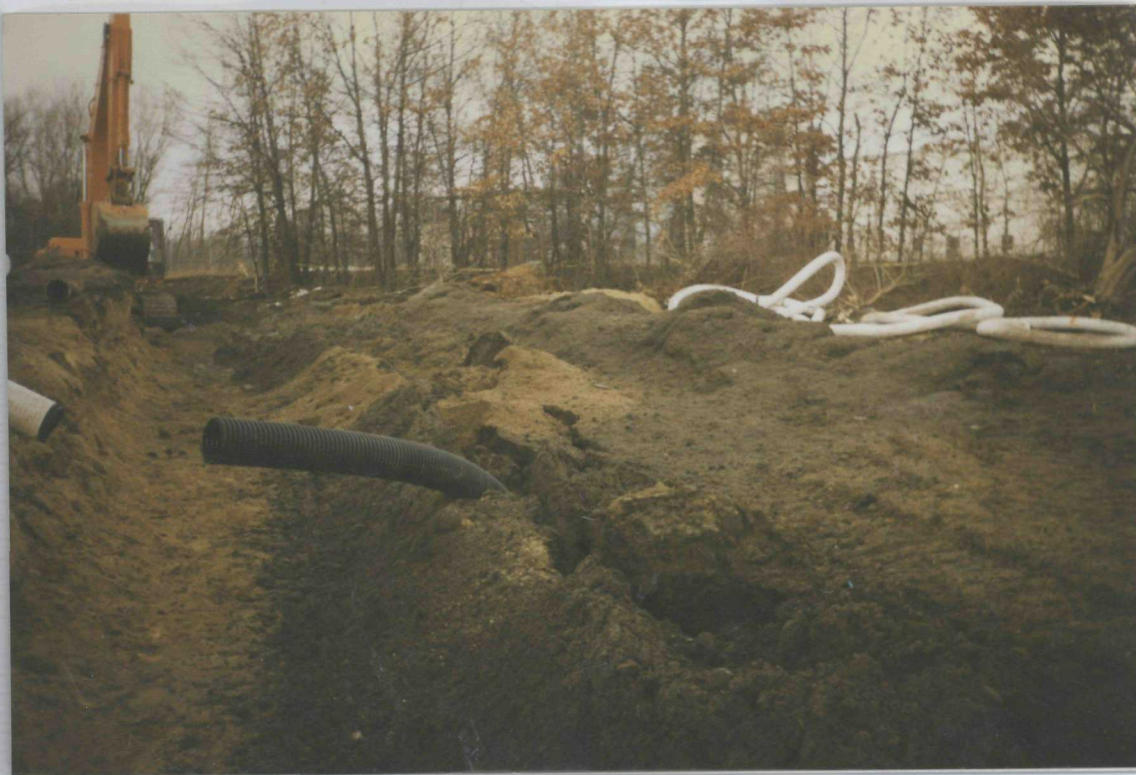
Description: Facing south-west. HTI completes the installation of extraction trench #11. The extraction trench culminated with a 15-foot long, solid, 6-inch corrugated HDPE pipe that will serve as an access port at the non-pumping end of the trench.

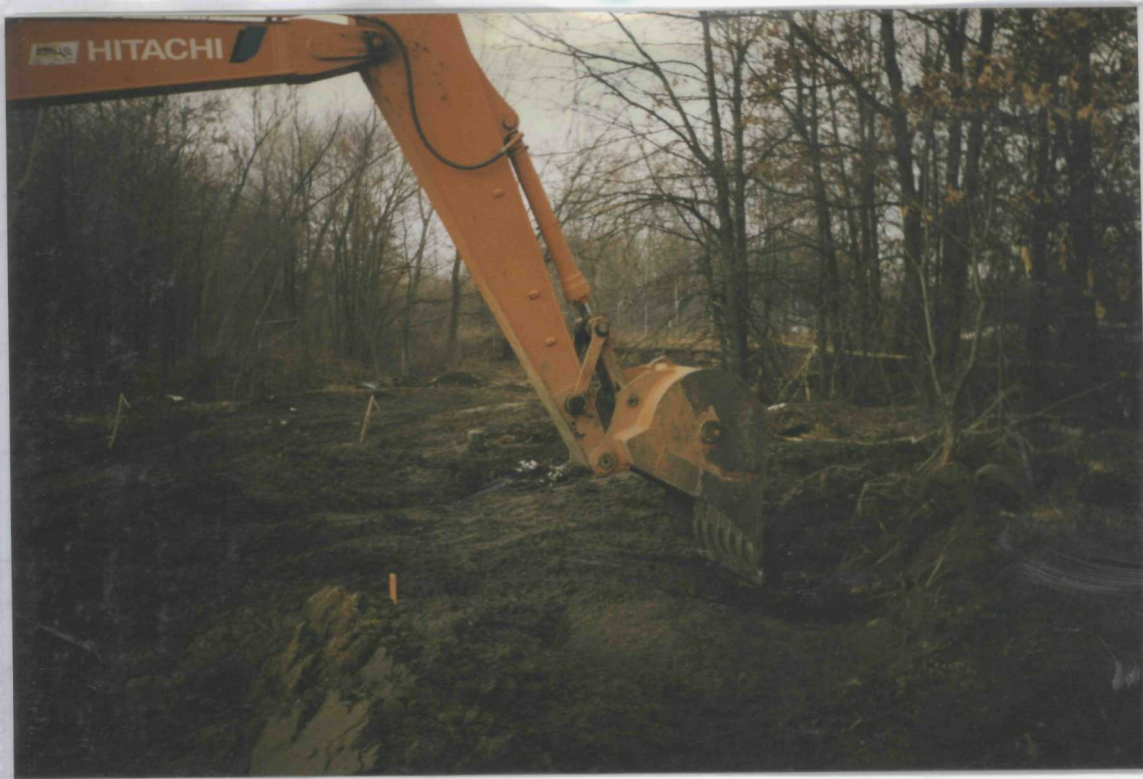
Site: American Chemical Services, Inc. RD/ERA
Proj. #: 71670.600
Roll: 1 Photo #: 64
Date: 02-09-97 Time: 1330
Photographer: Ashok Rupani
Description: Facing north-west. HTI cleaning up the area after
installation of extraction trench #11.

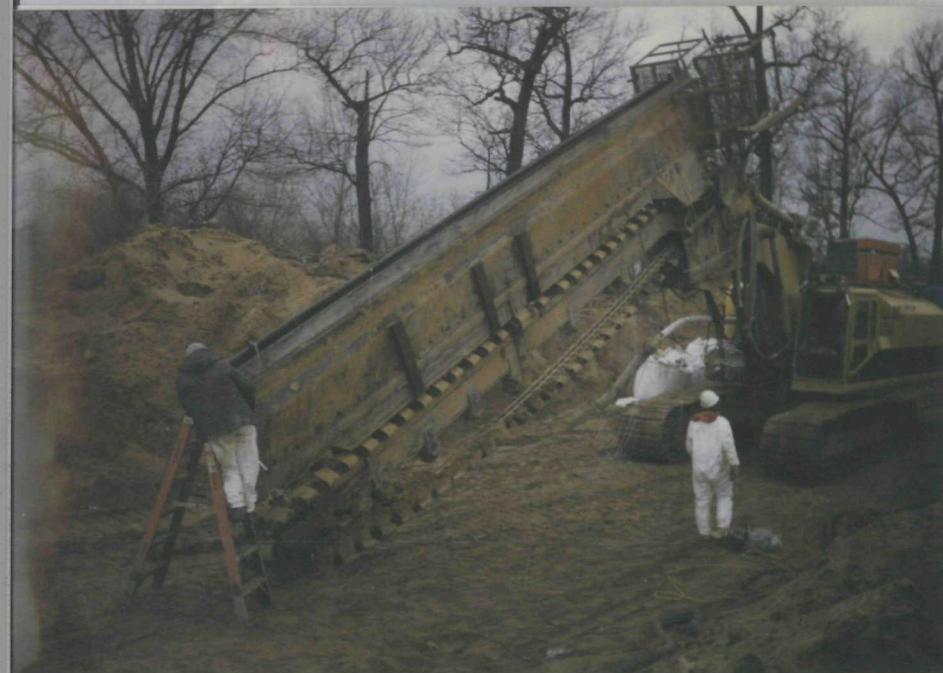
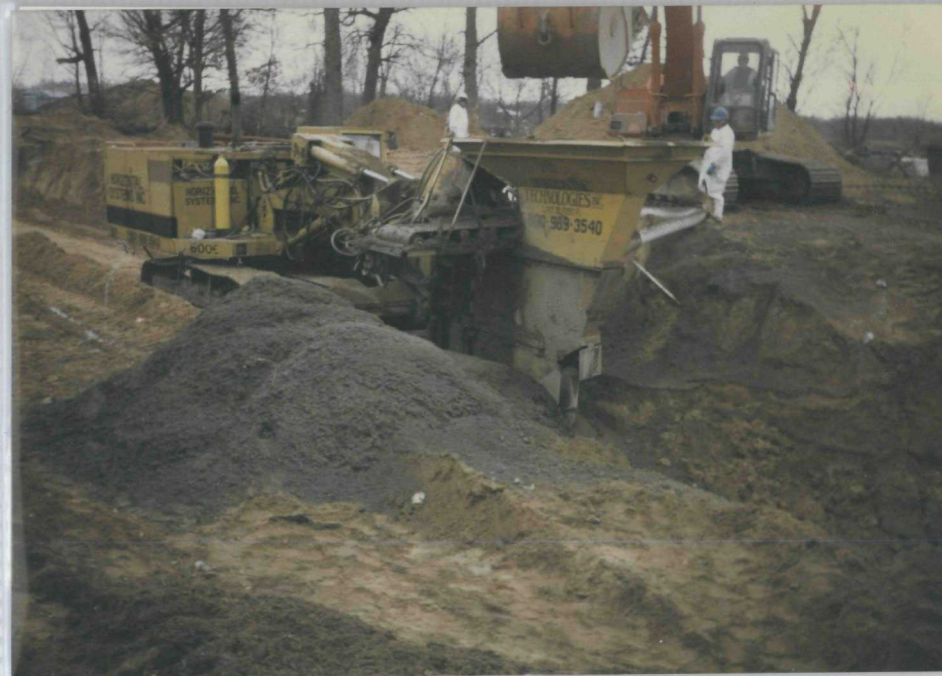
Description: Facing north-west. HTI repairing the installation boot and cutting chain of the trenching machine after cobbles and boulders, encountered during barrier wall installation along the eastern leg of the alignment, damaged the installation boot and the cutting chain of the machine.

Description: Facing south-west. HTI installing extraction trench #15.

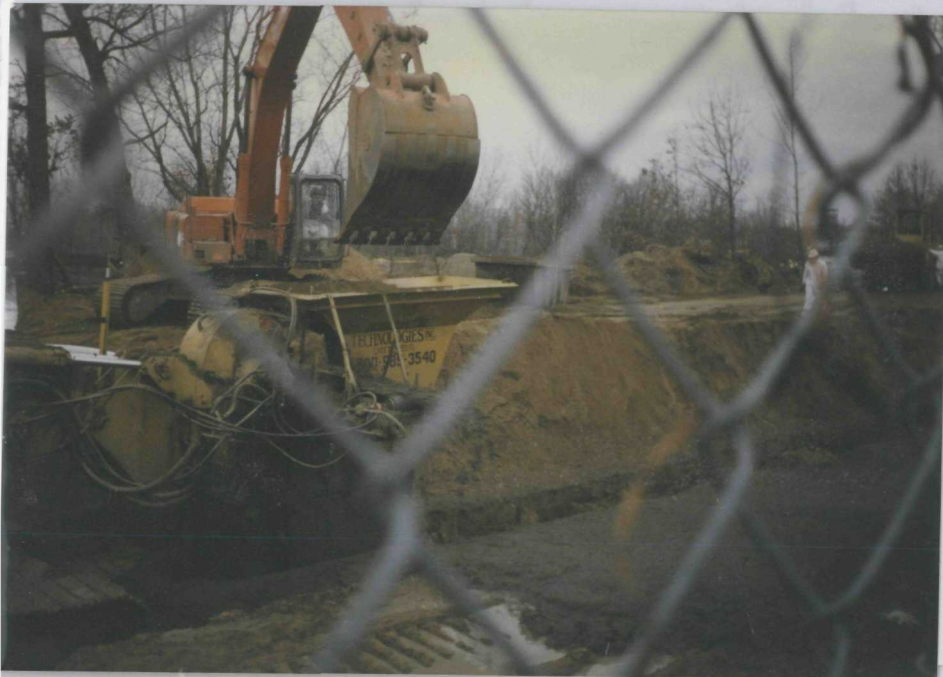
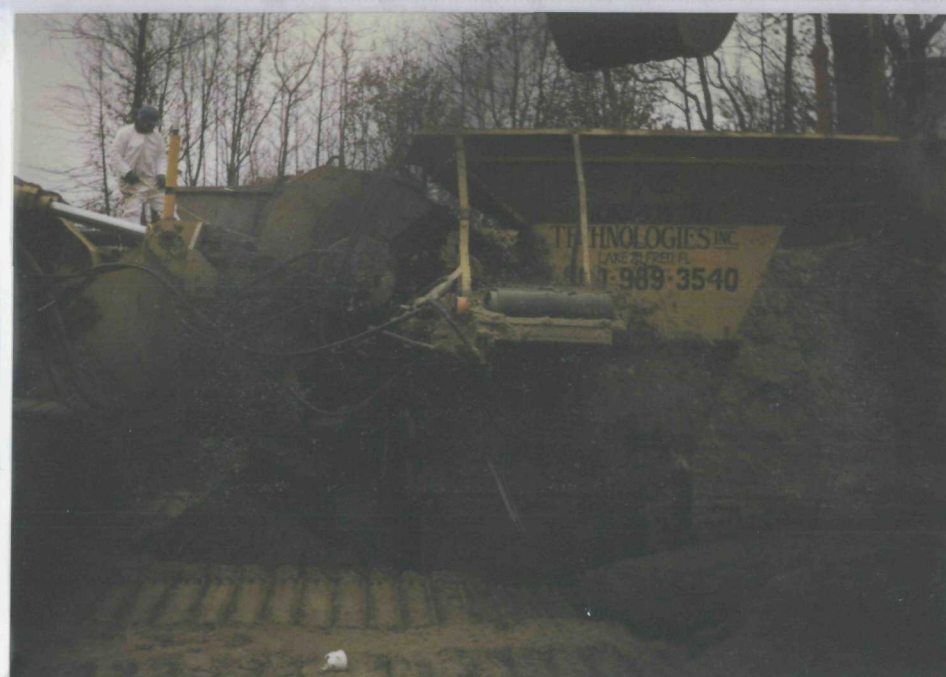
Site: American Chemical Services, Inc. RD/ERA
 Proj. #: 71670.600
 Roll: 5 Photo #: 67
 Date: 03-25-97 Time: 1720
 Photographer: Ashok Rupani
 Description: Facing west. HTI installing extraction trench #15.

Site: American Chemical Services, Inc. RD/ERA
 Proj. #: 71670.600
 Roll: 5 Photo #: 68
 Date: 03-25-97 Time: 0810
 Photographer: Ashok Rupani
 Description: Facing west. HTI installing extraction trench #16.

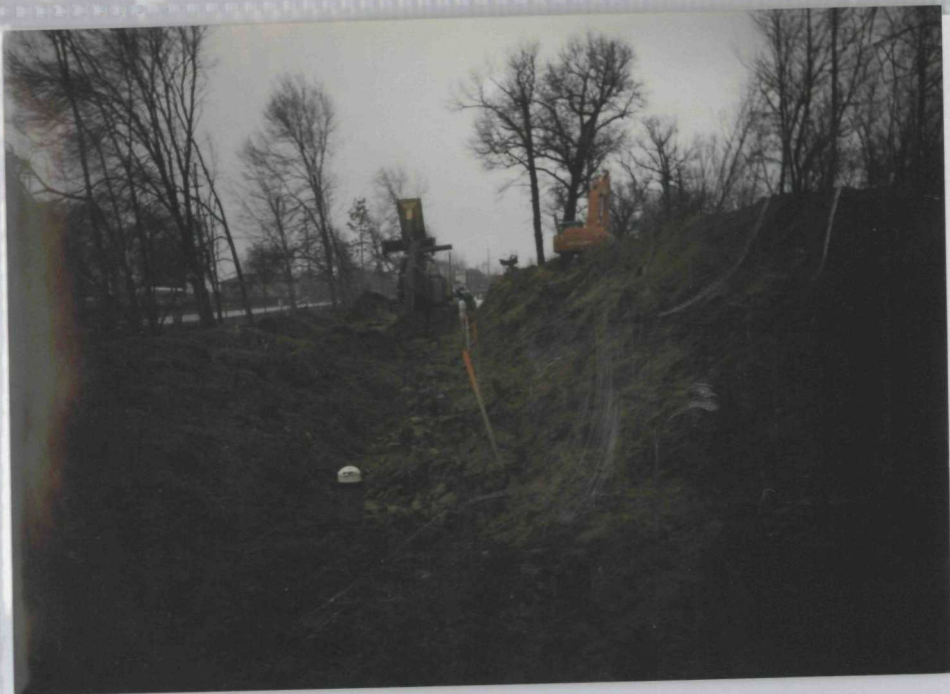
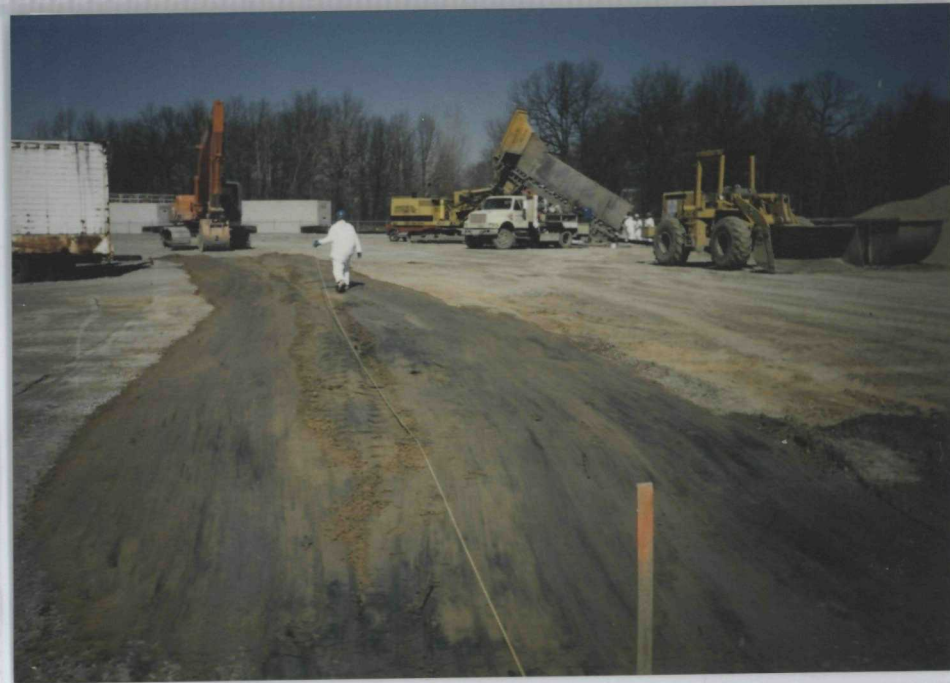
Description: Facing west. HTI setting up to install extraction trench #18 inside the ACS facility.

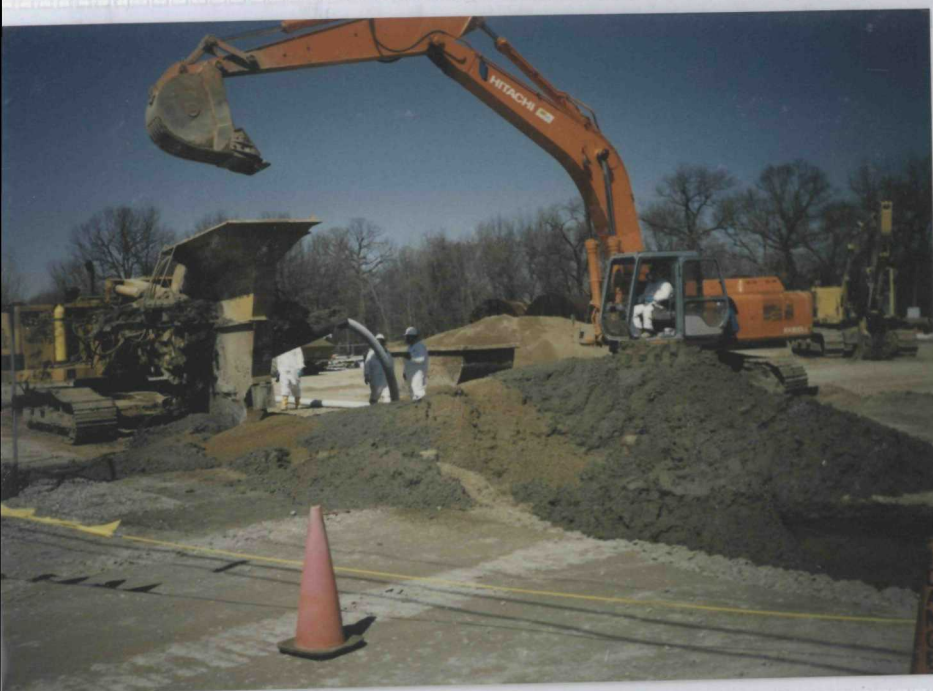
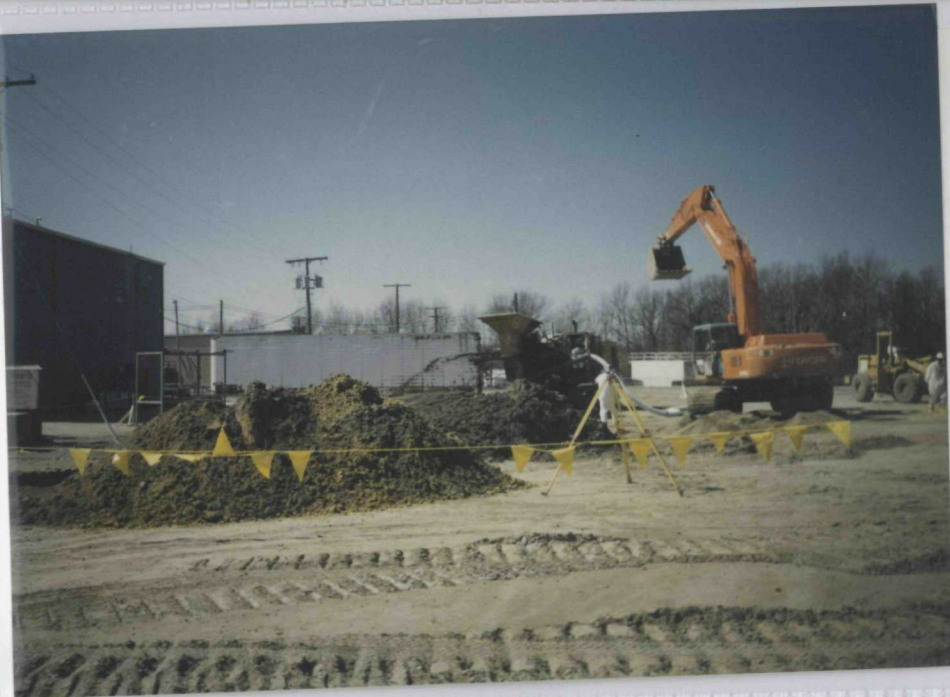
Site: American Chemical Services, Inc. RD/ERA
 Proj. #: 71670.600
 Roll: 5 Photo #: 71
 Date: 03-27-97 Time: 1225
 Photographer: Ashok Rupani
 Description: Facing north-west. HTI installing extraction trench #18.

Site: American Chemical Services, Inc. RD/ERA
 Proj. #: 71670.600
 Roll: 5 Photo #: 72
 Date: 03-27-97 Time: 1255
 Photographer: Ashok Rupani
 Description: Facing south-east. HTI installing extraction trench #18.

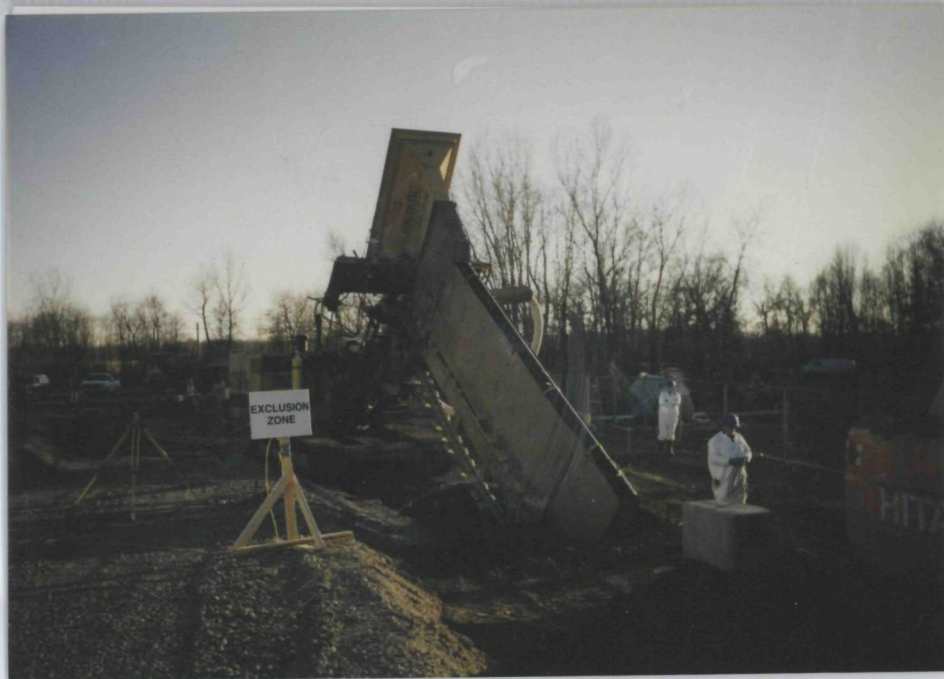
Site: American Chemical Services, Inc. RD/ERA
 Proj. #: 71670.600
 Roll: 5 Photo #: 73
 Date: 03-26-97 Time: 1725
 Photographer: Ashok Rupani
 Description: Facing south-west. HTI setting up to install extraction trench #10 inside the ACS facility.

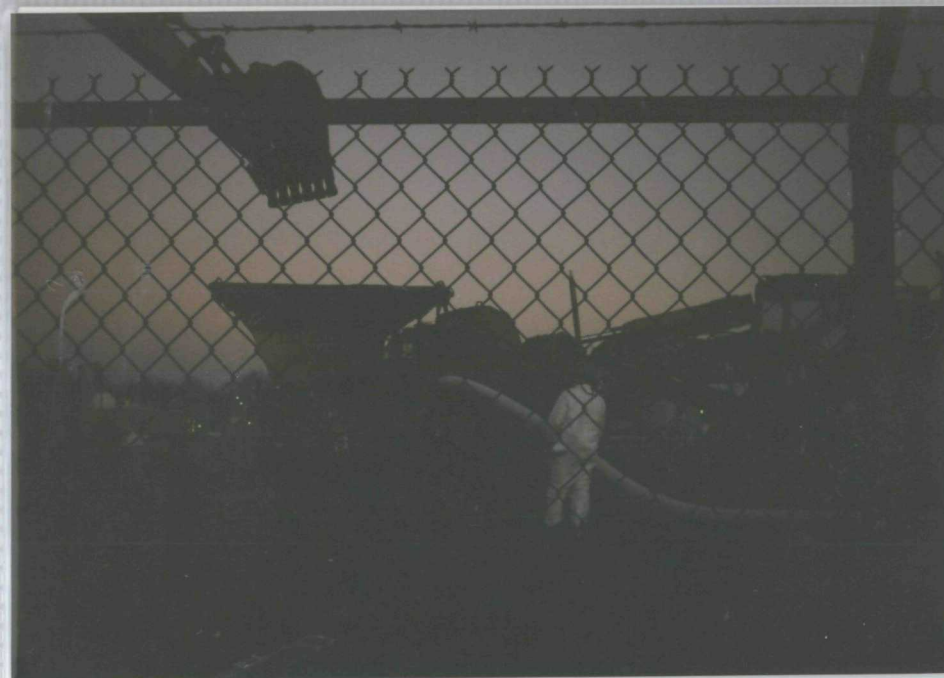
Site: American Chemical Services, Inc. RD/ERA
 Proj. #: 71670.600
 Roll: 5 Photo #: 74
 Date: 03-26-97 Time: 1820
 Photographer: Ashok Rupani
 Description: Facing east. HTI installing extraction trench #10.

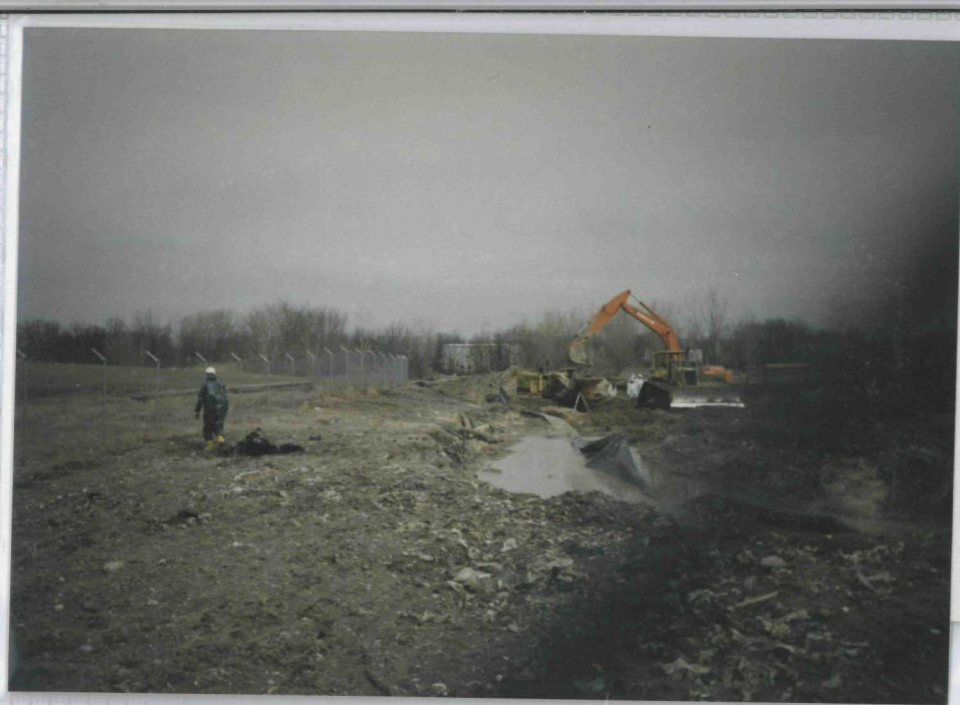
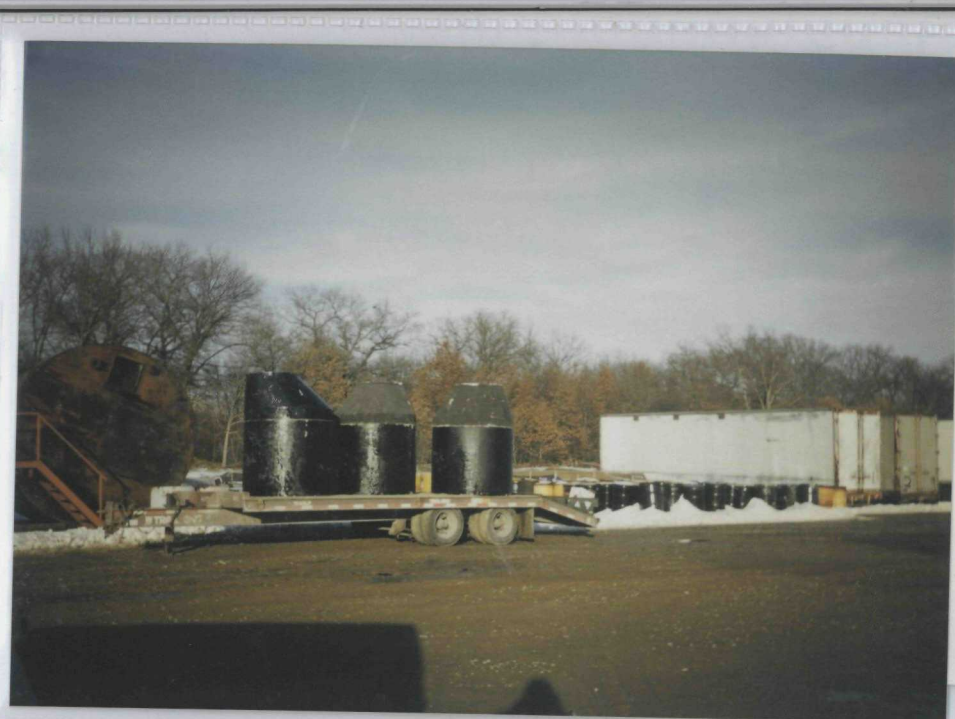
Site: American Chemical Services, Inc. RD/ERA
 Proj. #: 71670.600
 Roll: 4 Photo #: 75
 Date: 03-21-97 Time: 1000
 Photographer: Ashok Rupani
 Description: Facing north. HTI installing extraction trench #13.

Site: American Chemical Services, Inc. RD/ERA
 Proj. #: 71670.600
 Roll: 2 Photo #: 76
 Date: 02-17-97 Time: 1612
 Photographer: Ashok Rupani
 Description: Facing north. The three manholes for the effluent discharge system were delivered to the site pre-assembled.

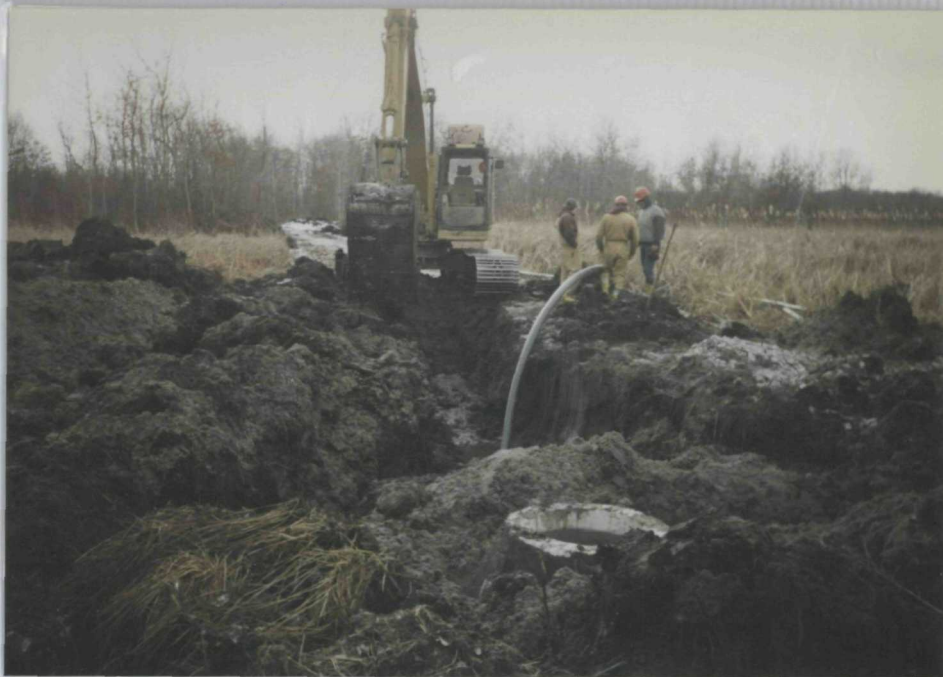
Site: American Chemical Services, Inc. RD/ERA
 Proj. #: 71670.600
 Roll: 2 Photo #: 77
 Date: 02-18-97 Time: 1045
 Photographer: Ashok Rupani
 Description: Facing south-east. Youngs installing the manhole for the northern leg of the effluent discharge system.

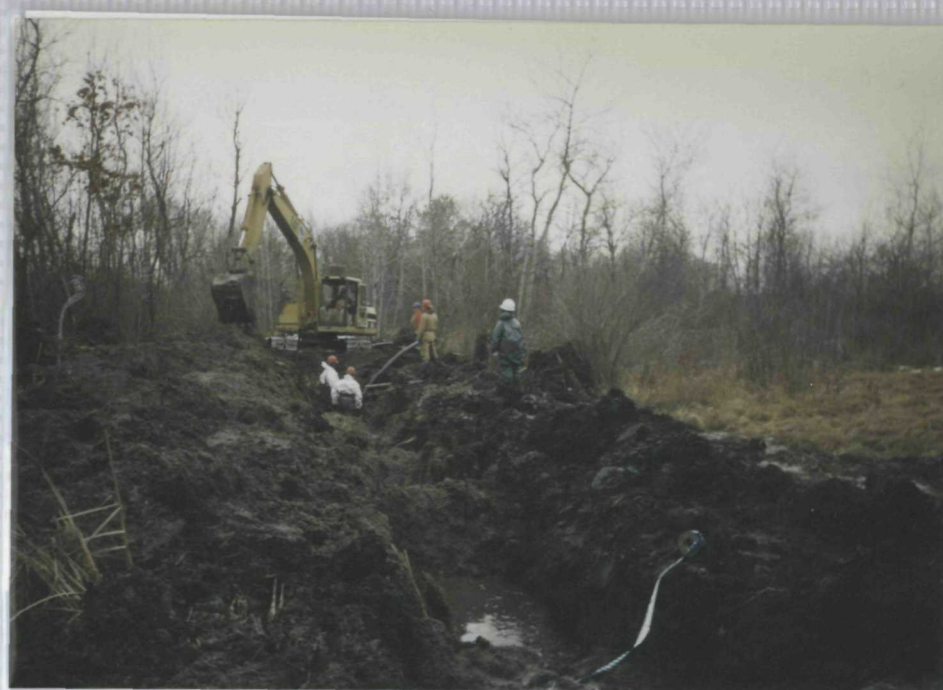
Site: American Chemical Services, Inc. RD/ERA
 Proj. #: 71670.600
 Roll: 2 Photo #: 78
 Date: 02-18-97 Time: 1335
 Photographer: Ashok Rupani
 Description: Facing south-east. Youngs installing a 4-inch high density polyethylene (HDPE) pipe for the northern leg of the effluent discharge system.
